# VEHICLE INSPECTION REPORT

**PF70EAW**

## Fiat Ducato 2.3 Multijet 140

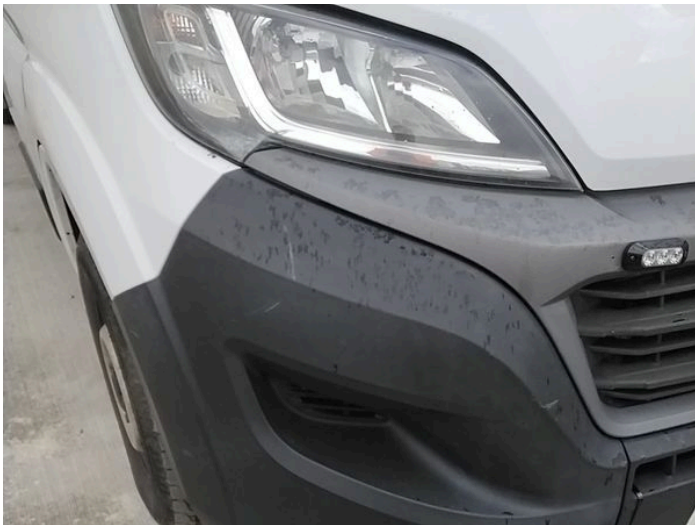
1: Bumper Front Moulding  
Scuffed (Unpainted)  
Over 100mm

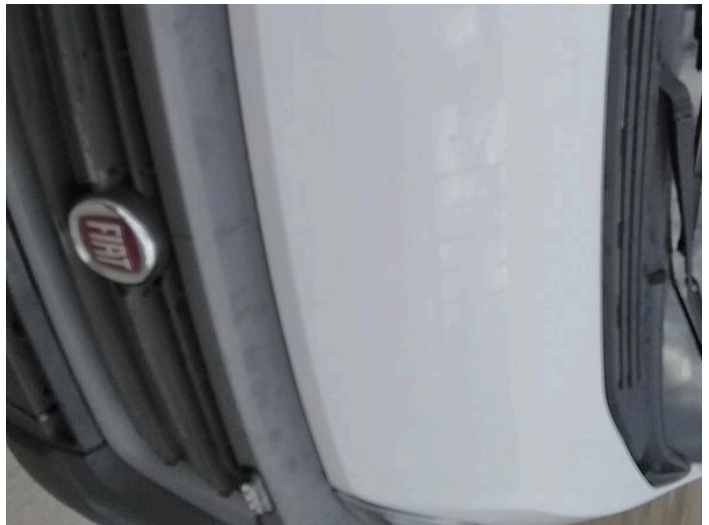
2: Bonnet  
Chipped  
Multiple Chips

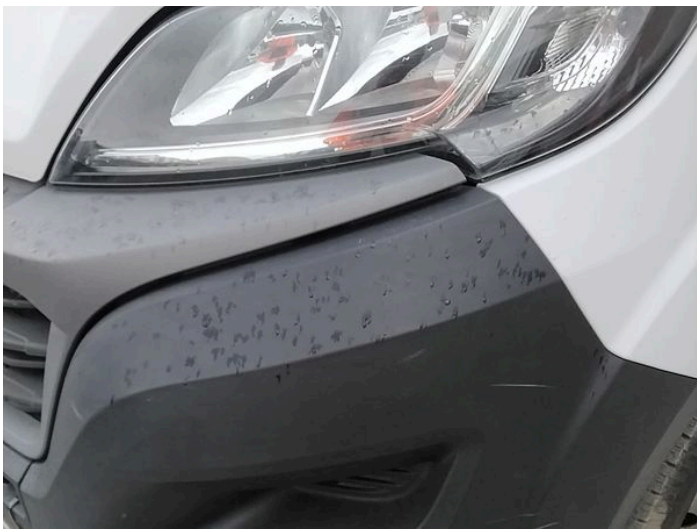
3: Bumper Front Moulding  
Scuffed (Unpainted)  
UpTo 100mm

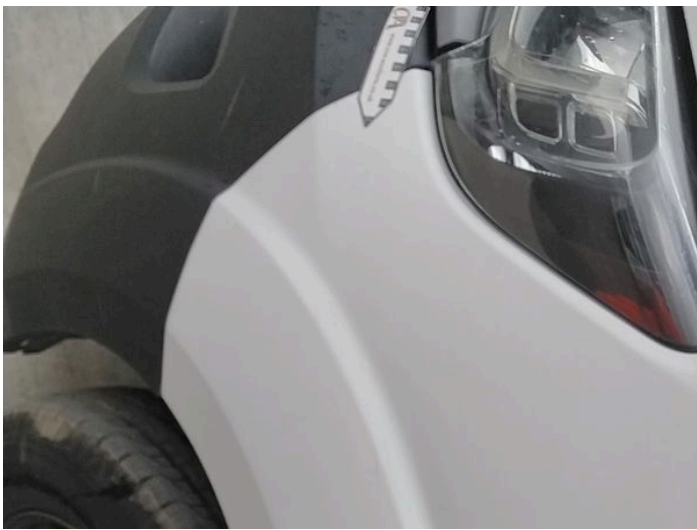
4: Wing nsf  
Scratched  
Over 25mm Not Thru Paint

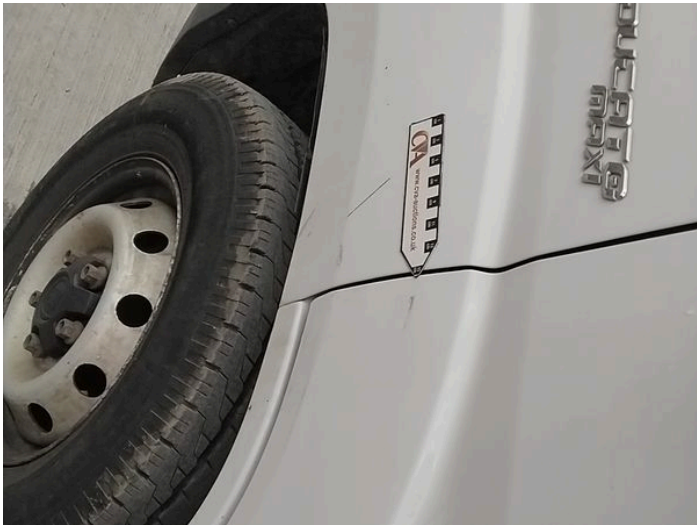
5: Door nsf  
Scratched  
Over 25mm Thru Paint

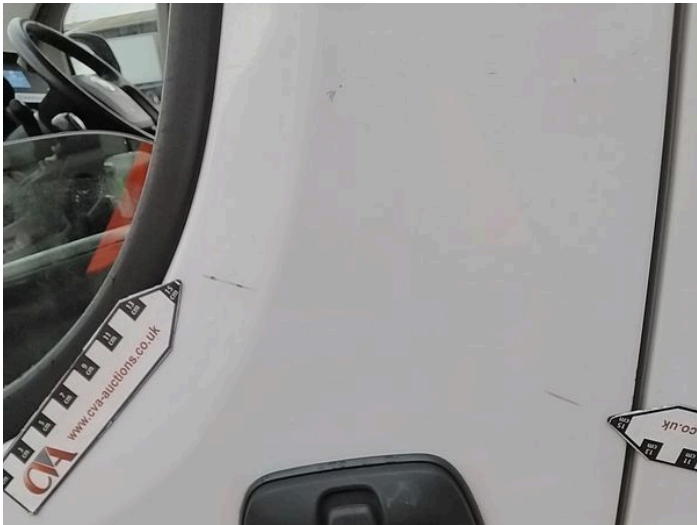
6: Door nsf  
Scratched  
Over 25mm Thru Paint

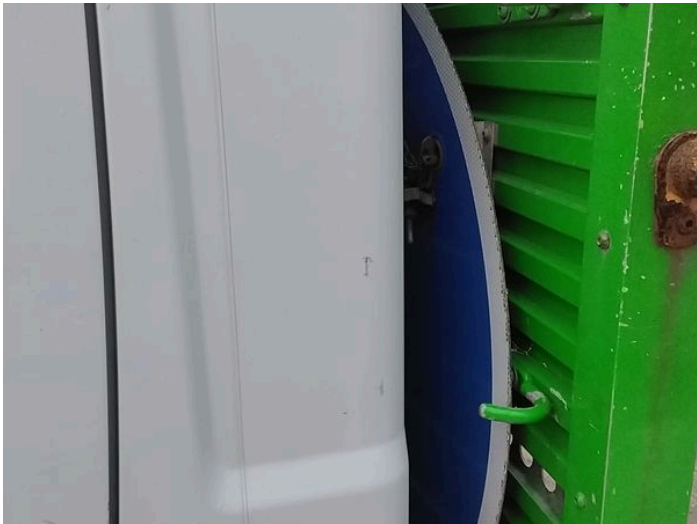
7: B Post ns  
Chipped  
Multiple Chips

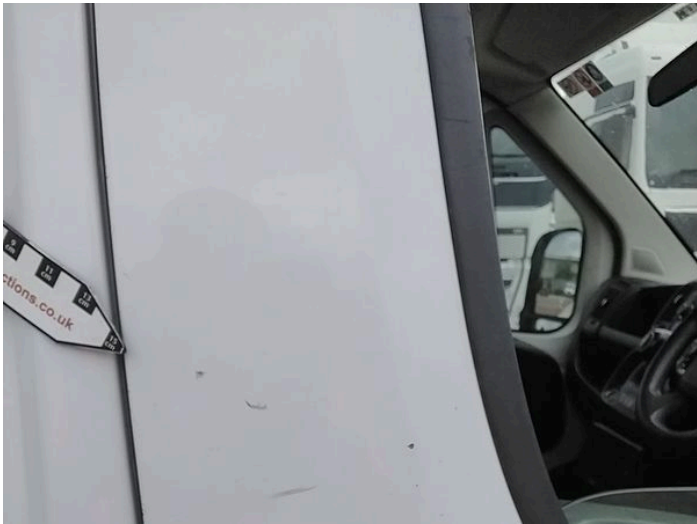
8: Door osf  
Scratched  
Over 25mm Thru Paint

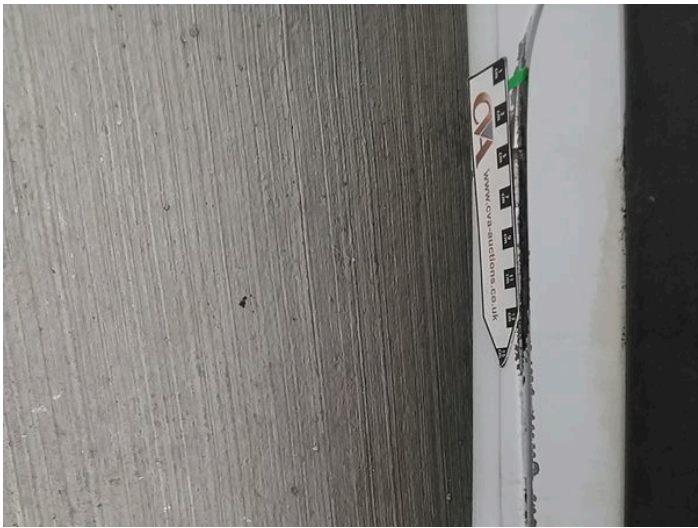
9: Sill os  
Dented  
With Paint Damage

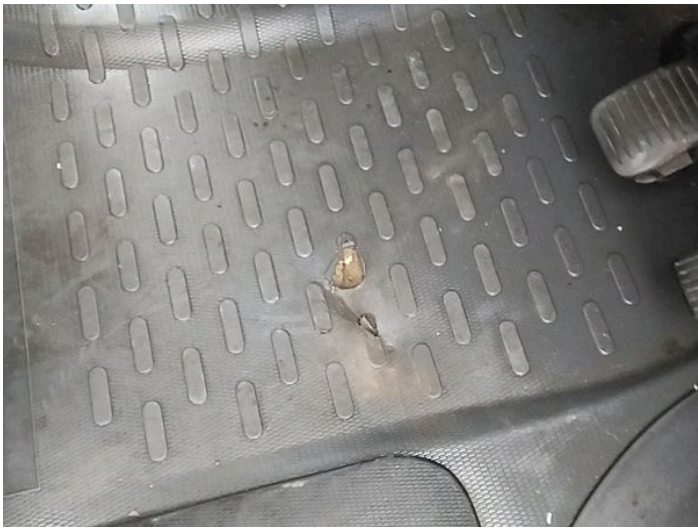
10: Carpets Front  
Holed  
Over 3mm

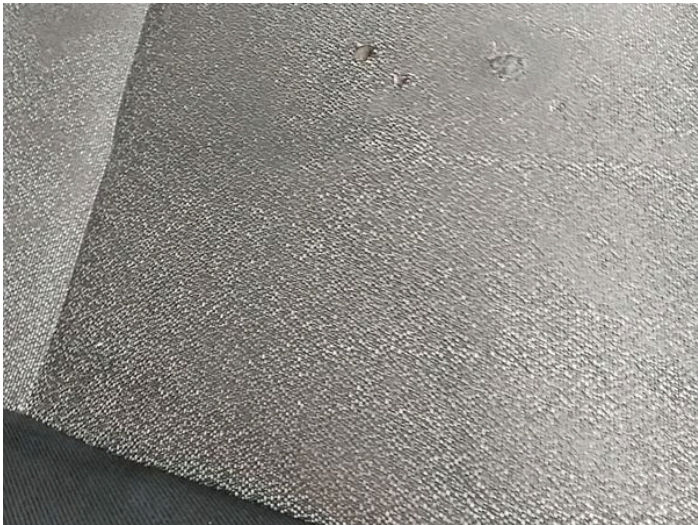
11: Seat Base Cover osf  
Burn  
Over 3mm

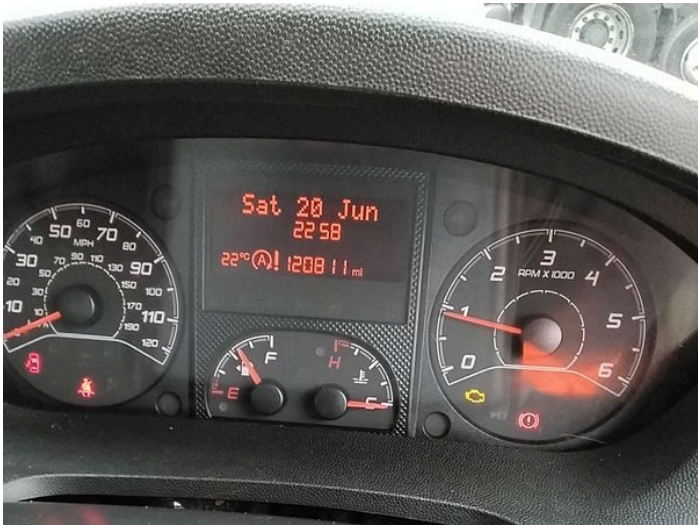
\*WARNING LIGHT ON DASH\* AD-BLUE, E/MIRRORS

12: Dash Warning Lights  
Displayed  
No Action
