## VEHICLE INSPECTION REPORT

**BX09FYL**

### Daf LF 45.180

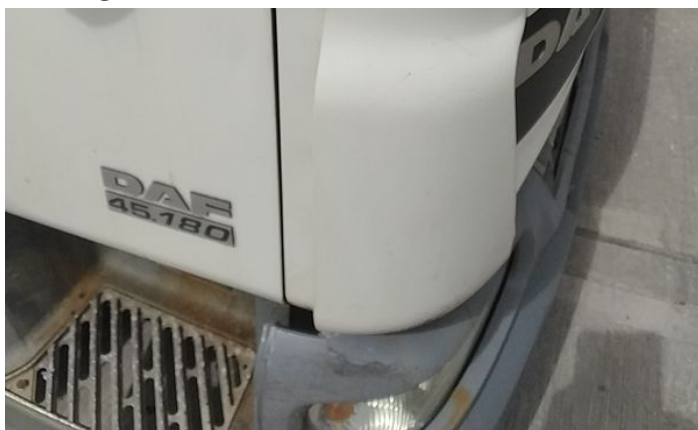
1: Panel Front  
Scratched  
Over 25mm Thru Paint

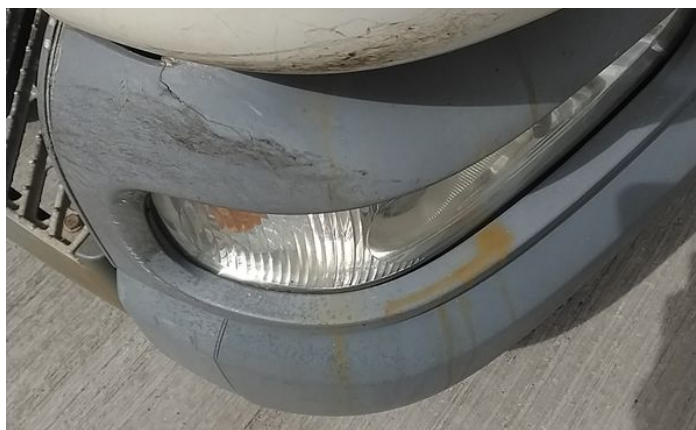
2: Bumper Front Moulding  
Broken  
Replace

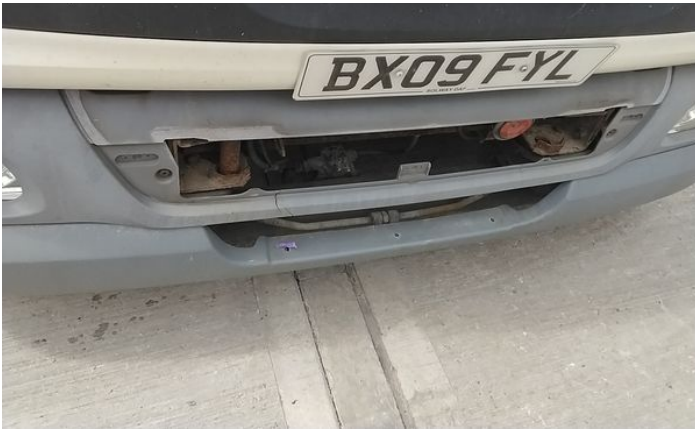
3: Bumper Front Grill  
Missing  
Replace

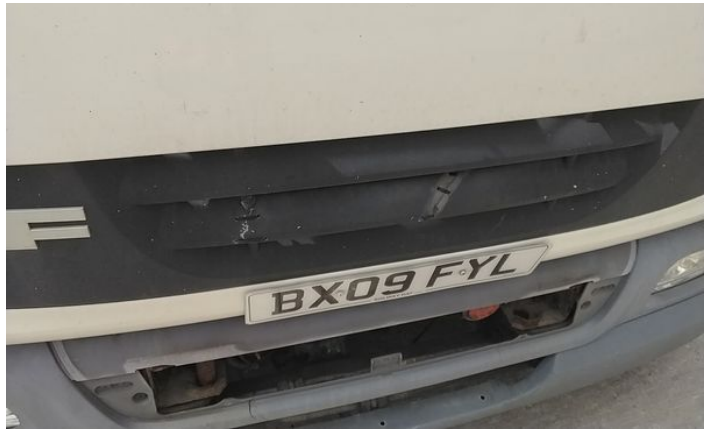
4: Bonnet  
Cracked  
Replace

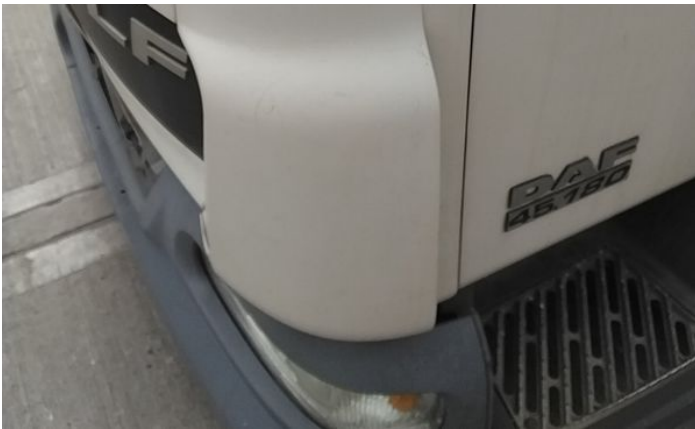
5: Panel Front  
Scratched  
Over 25mm Thru Paint

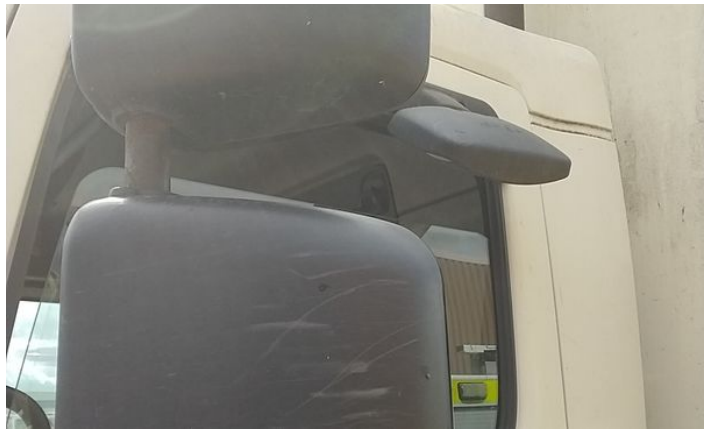
6: Door Mirror Assy nsf  
Scuffed (Unpainted)  
Over 100mm

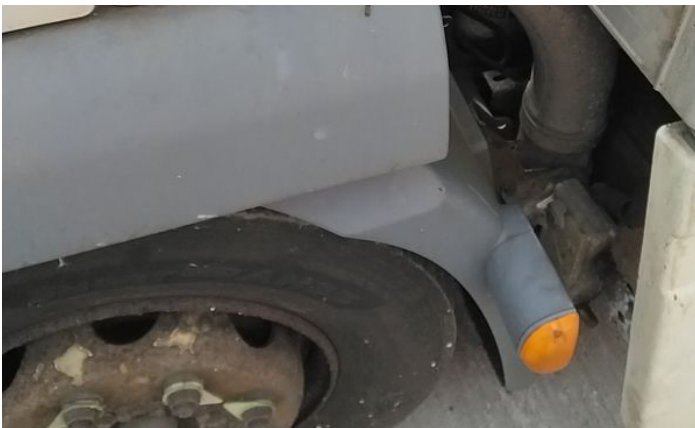
7: B Post ns  
Rusted  
Over 5mm

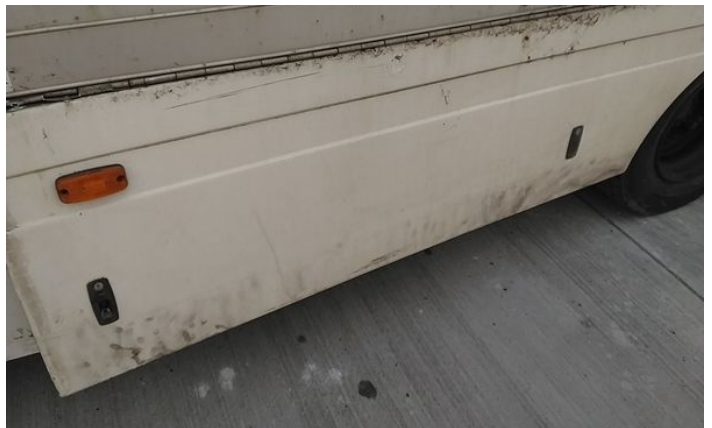
8: Qtr Panel Moulding ns  
Scratched (Painted)  
Over 25mm Thru Paint

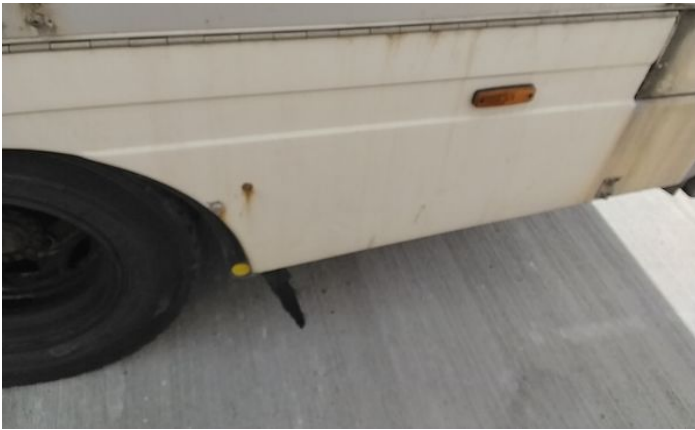
9: Qtr Panel Moulding ns  
Scratched (Painted)  
Over 25mm Thru Paint

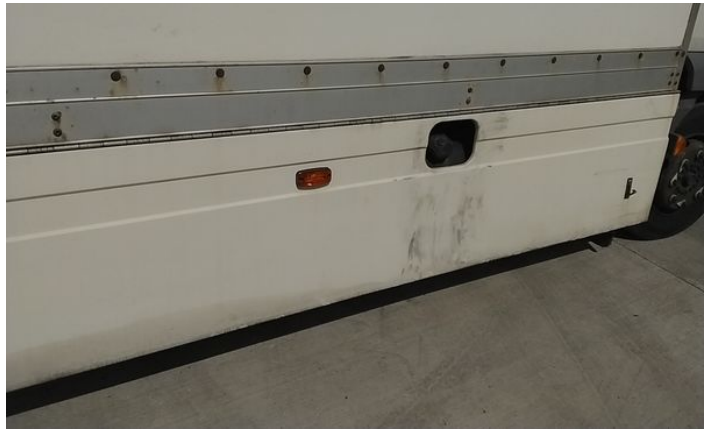
10: Qtr Panel Moulding os  
Scratched (Painted)  
Over 25mm Thru Paint

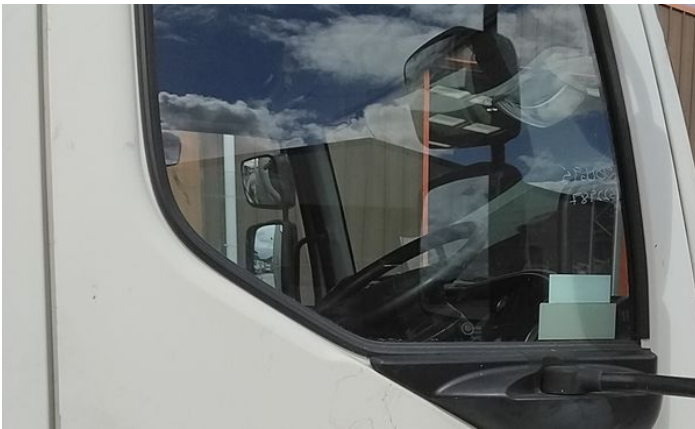
11: Door osf  
Scratched  
Over 25mm Thru Paint

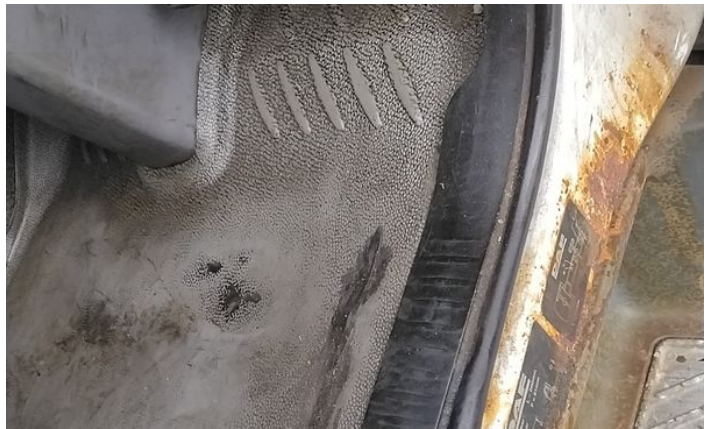
12: Carpets Front  
Torn  
Over 10mm

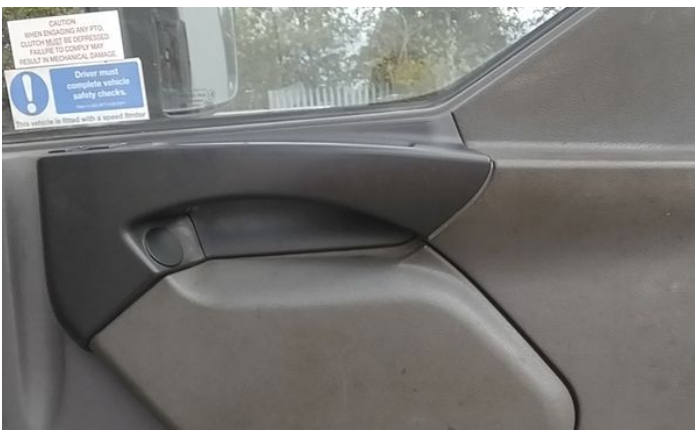
13: Door Pad osf  
Soiled  
Heavy

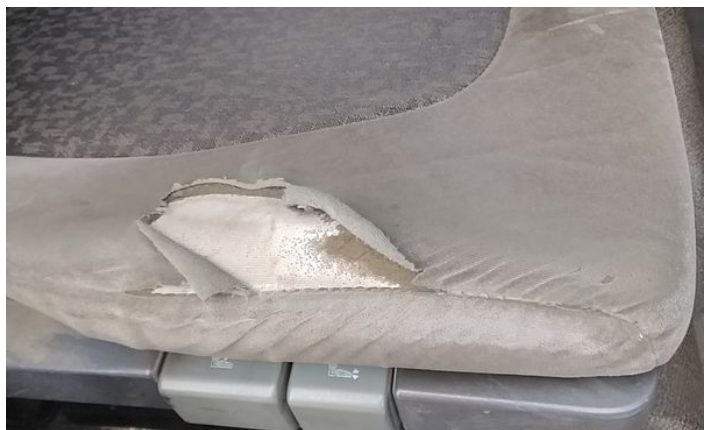
14: Seat Base Cover osf  
Holed  
Over 3mm

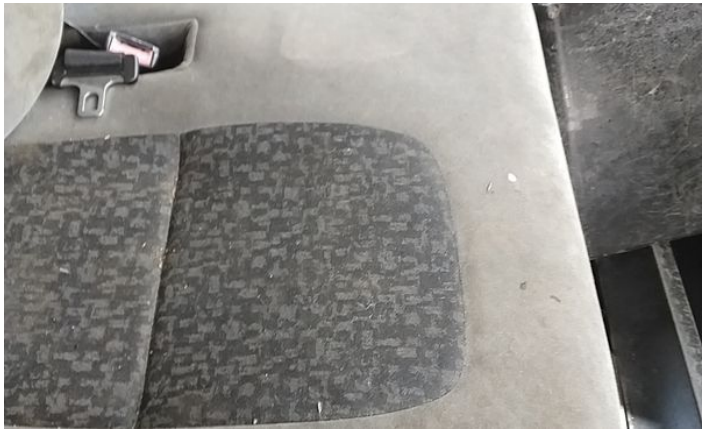
15: Seat Base Cover nsf  
Soiled  
Heavy
